EASTLAND LAKE DAM
BATES COUNTY, MISSOURI
MISSOURI INVENTORY NO. 20444

PHASE I INSPECTION REPORT
NATIONAL DAM SAFETY PROGRAM

PHASE I REPORT
NATIONAL DAM SAFETY PROGRAM
SUMMARY

Name of Dam: Eastland Lake Dam
State Located: Missouri
County Located: Bates
Stream: Tributary of Muddy Creek
Date of Inspection: July 16, 1980

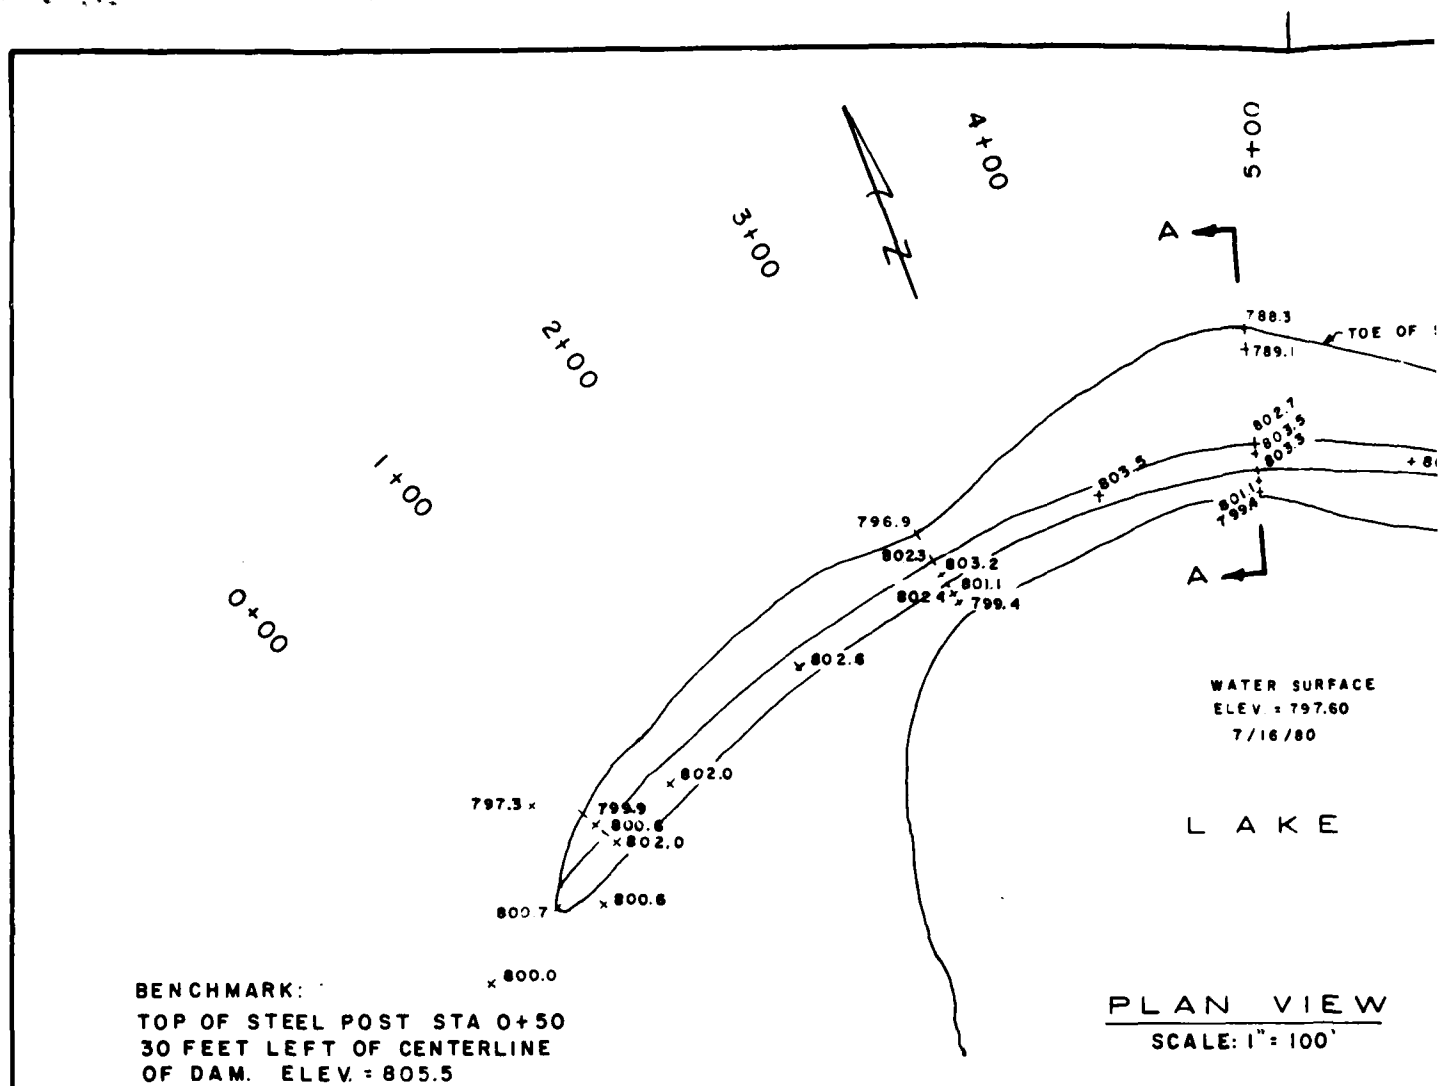
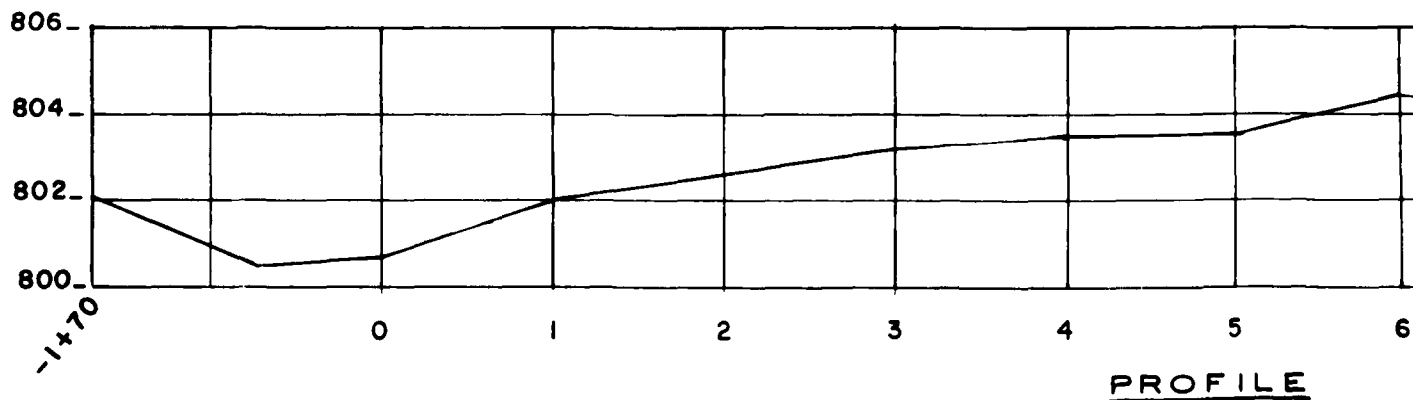
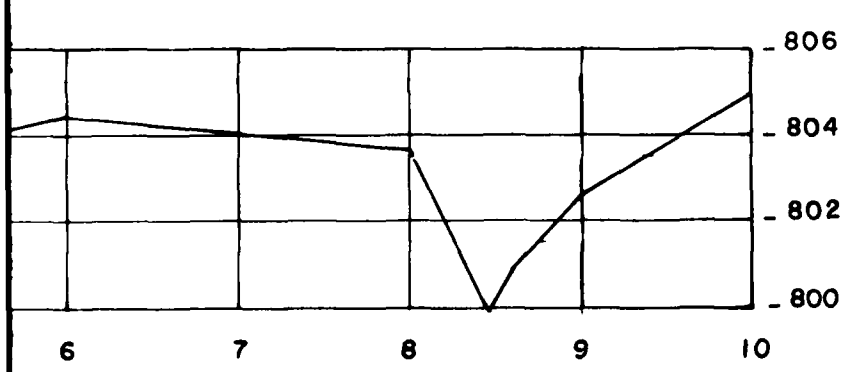
SHEET 3 APPENDIX A

Sheet 3 of Appendix A shows a plan, profile, and typical section of the embankments. Sheet 3A of Appendix A shows a profile and section of the spillway.
